MALINE CREEK ASBESTOS SITE CLOSURE AND STREAMBANK STABILIZATION STUDY

ST. LOUIS, MISSOURI

March 1993

EPA Contract No. 68-52-7002
Work Order No. 7002-06
SBA Contract No. 79220037

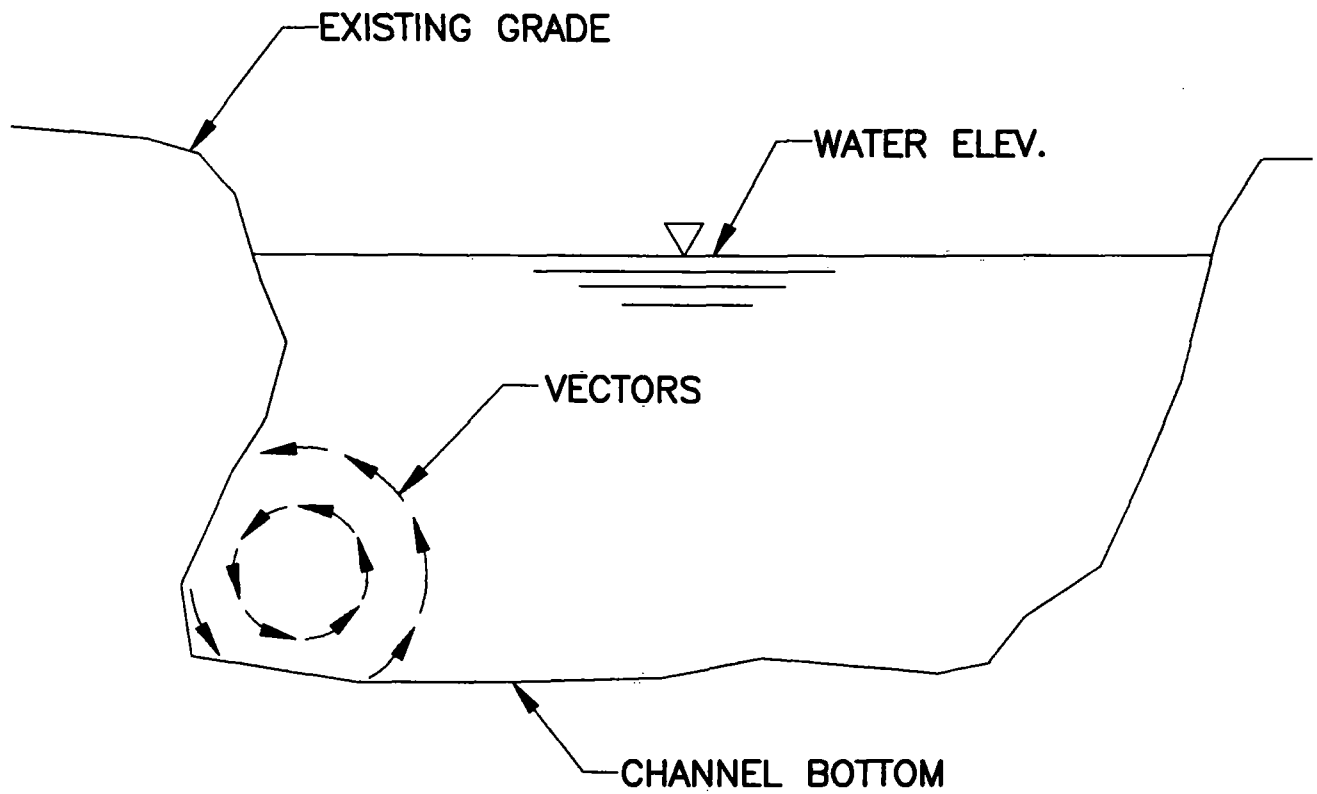
**FIGURE II-2
CREEK SECTION SHOWING
SPRIAL FLOW VELOCITY
VECTORS**

The spiral currents generated as water moves through bends are of particular concern in the Certainteed-GAF reach. This phenomenon is peculiar to subcritical flow and accounts for much of the embankment scour which can be seen even in some relatively tranquil streams. Such currents describe a helical path in the direction of flow and introduce transverse velocity components to the channel section (Figure II). These currents are believed to be caused by filamental velocity differences between the center of the channel and the channel wall induced by friction; centrifugal force which deflects water particles from straight line motion; and a vertical velocity distribution in the approach channel which initiates the spiral motion. Looking downstream, a bend to the right induces counterclockwise motion, while a bend to the left induces clockwise motion. Such currents are probably the primary reason for the severe undermining process seen at and below the Riverview Branch tributary bend. Spiral currents tend to persist for some distance downstream when a curve is followed by a long straight tangent and, therefore, their impact is not merely local. The extensive damage done along the Certainteed-GAF northeast bank well below the bend is a prime example of their effect.

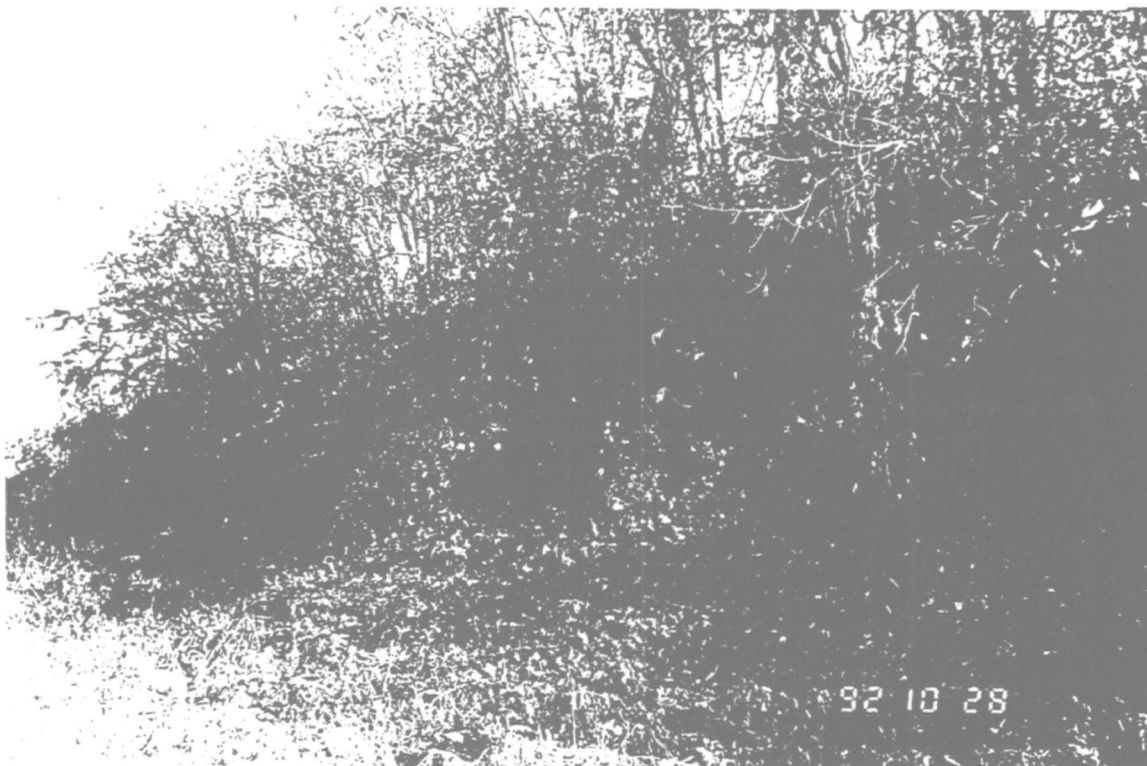
Asbestos containing materials are exposed in the creek bank, bottom of the river bed and on the surface. The most visible contaminations is along the east bank of Maline Creek near St. Cyr road, where a stratum of white asbestos containing material is exposed to the surface. This layer of asbestos material is about two feet below the surface and is about two to five feet in thickness. This stratum is exposed along the bank for about 300 feet in length (Figure III-1 and III-2).

Figure III - 1 Looking North at approximately 1/2 mile
SE of Riverview Branch tributary.

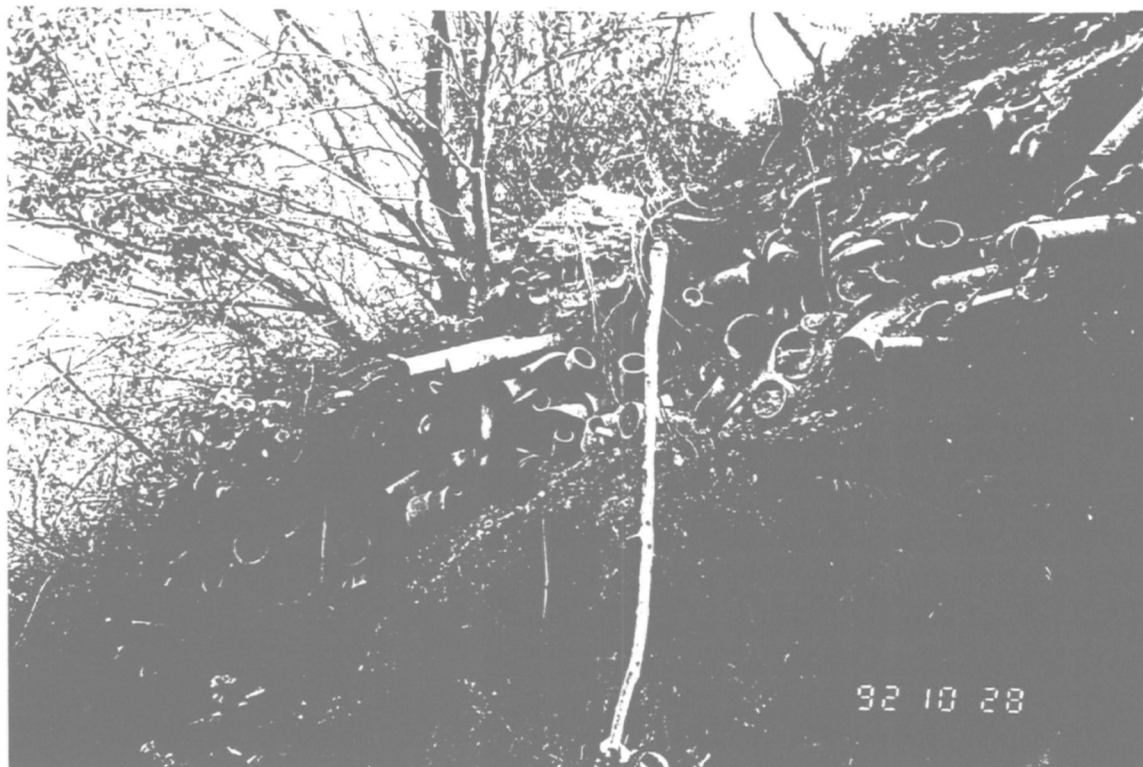
Figure III - 2 Close-up of NE bank from Riverview Branch
tributary, approximately 1/2 mile SE of
tributary to show stratum of asbestos
materials

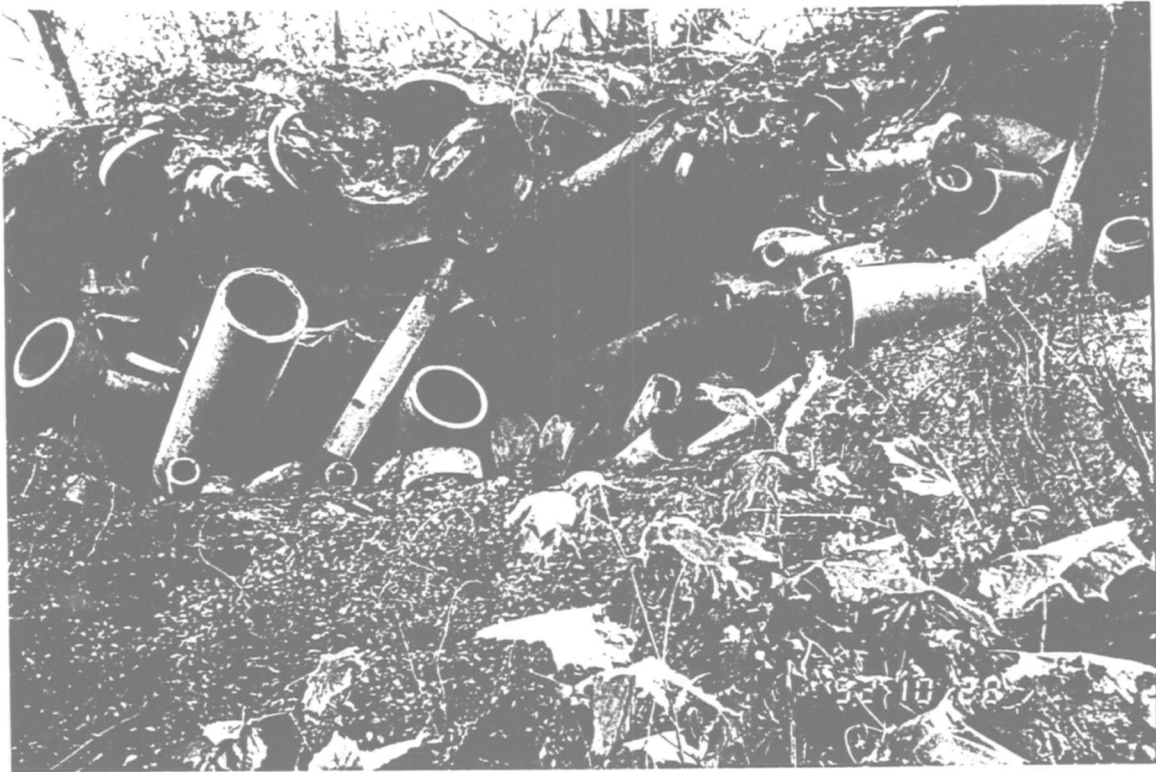
Figure III - 6 Transite pipe, connectors and pipe collars along NE bank from Riverview Branch tributary.

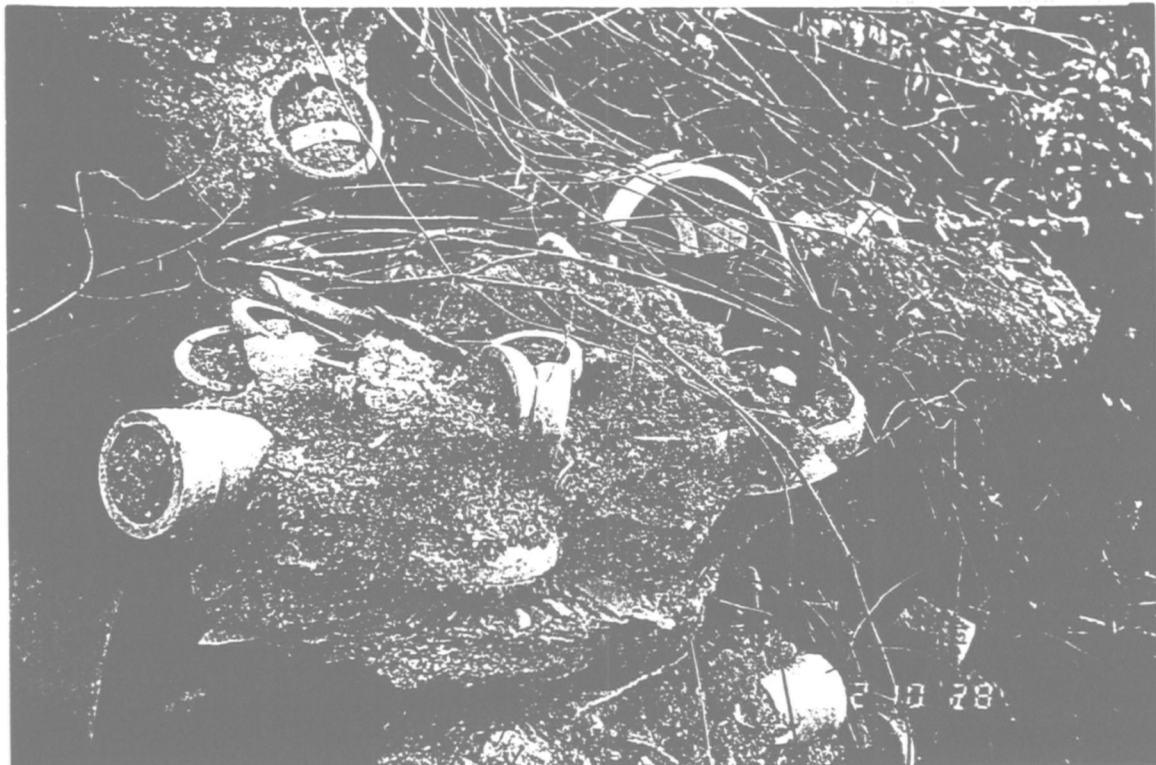
Friable materials identified at the site include pipe insulation, impregnated cloth and solidified cement slurry. Weathering and deterioration of non friable materials may lead to delamination, where the material begins to split and pull apart thus releasing fibers.

Figure III - 7 Close-up of asbestos pipe in solidified slurry.
